TWO SERENDRA FINDINGS

DILG

On 31 May 2013, at approximately 7:59 p.m., an explosion took place in Unit 501-B, Section B, Tower A, Two Serendra, McKinley Parkway Drive, Bonifacio Global City (BGC), Taguig City.

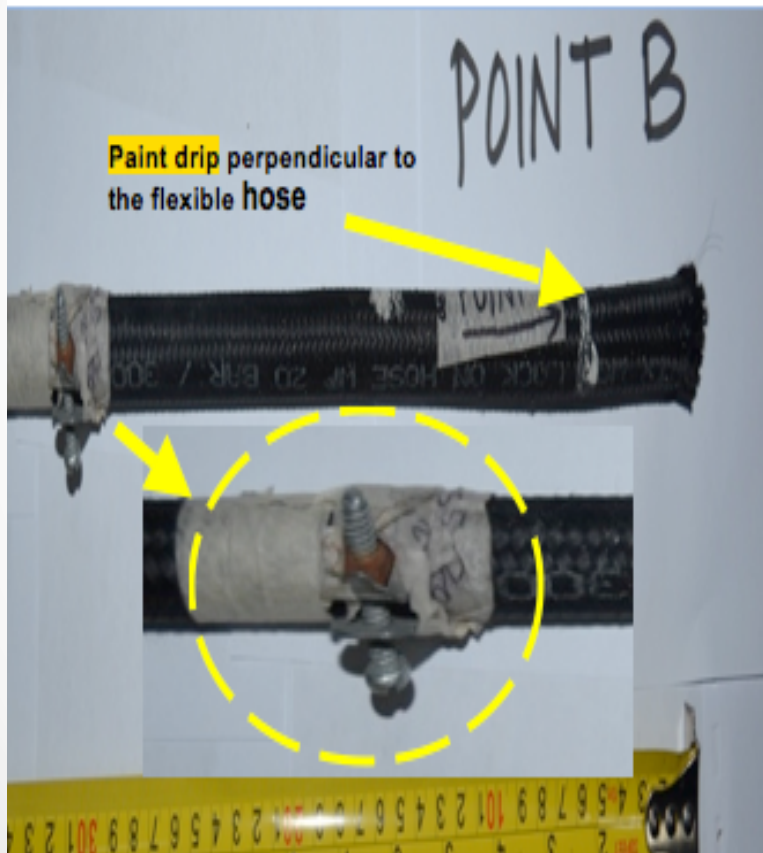
A. Unauthorized* Movement of Gas Range Caused a Detachment of the Gas Supply Hose

Loose Clamp

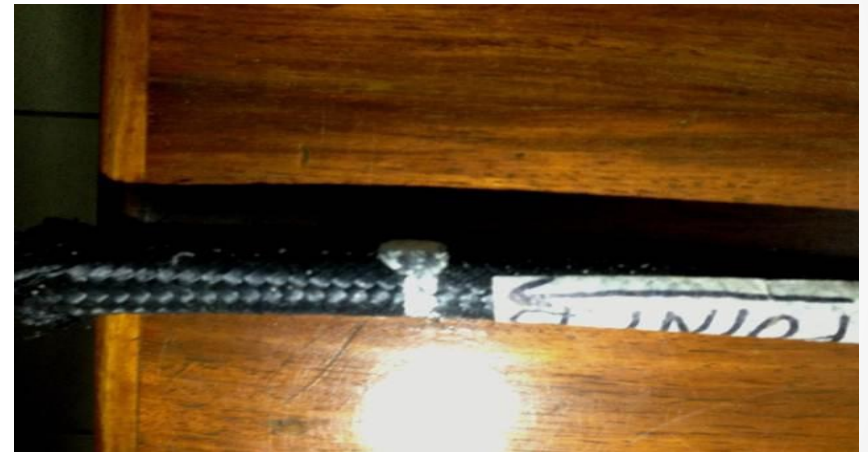
Paint drip showing hose
was lying on the floor.

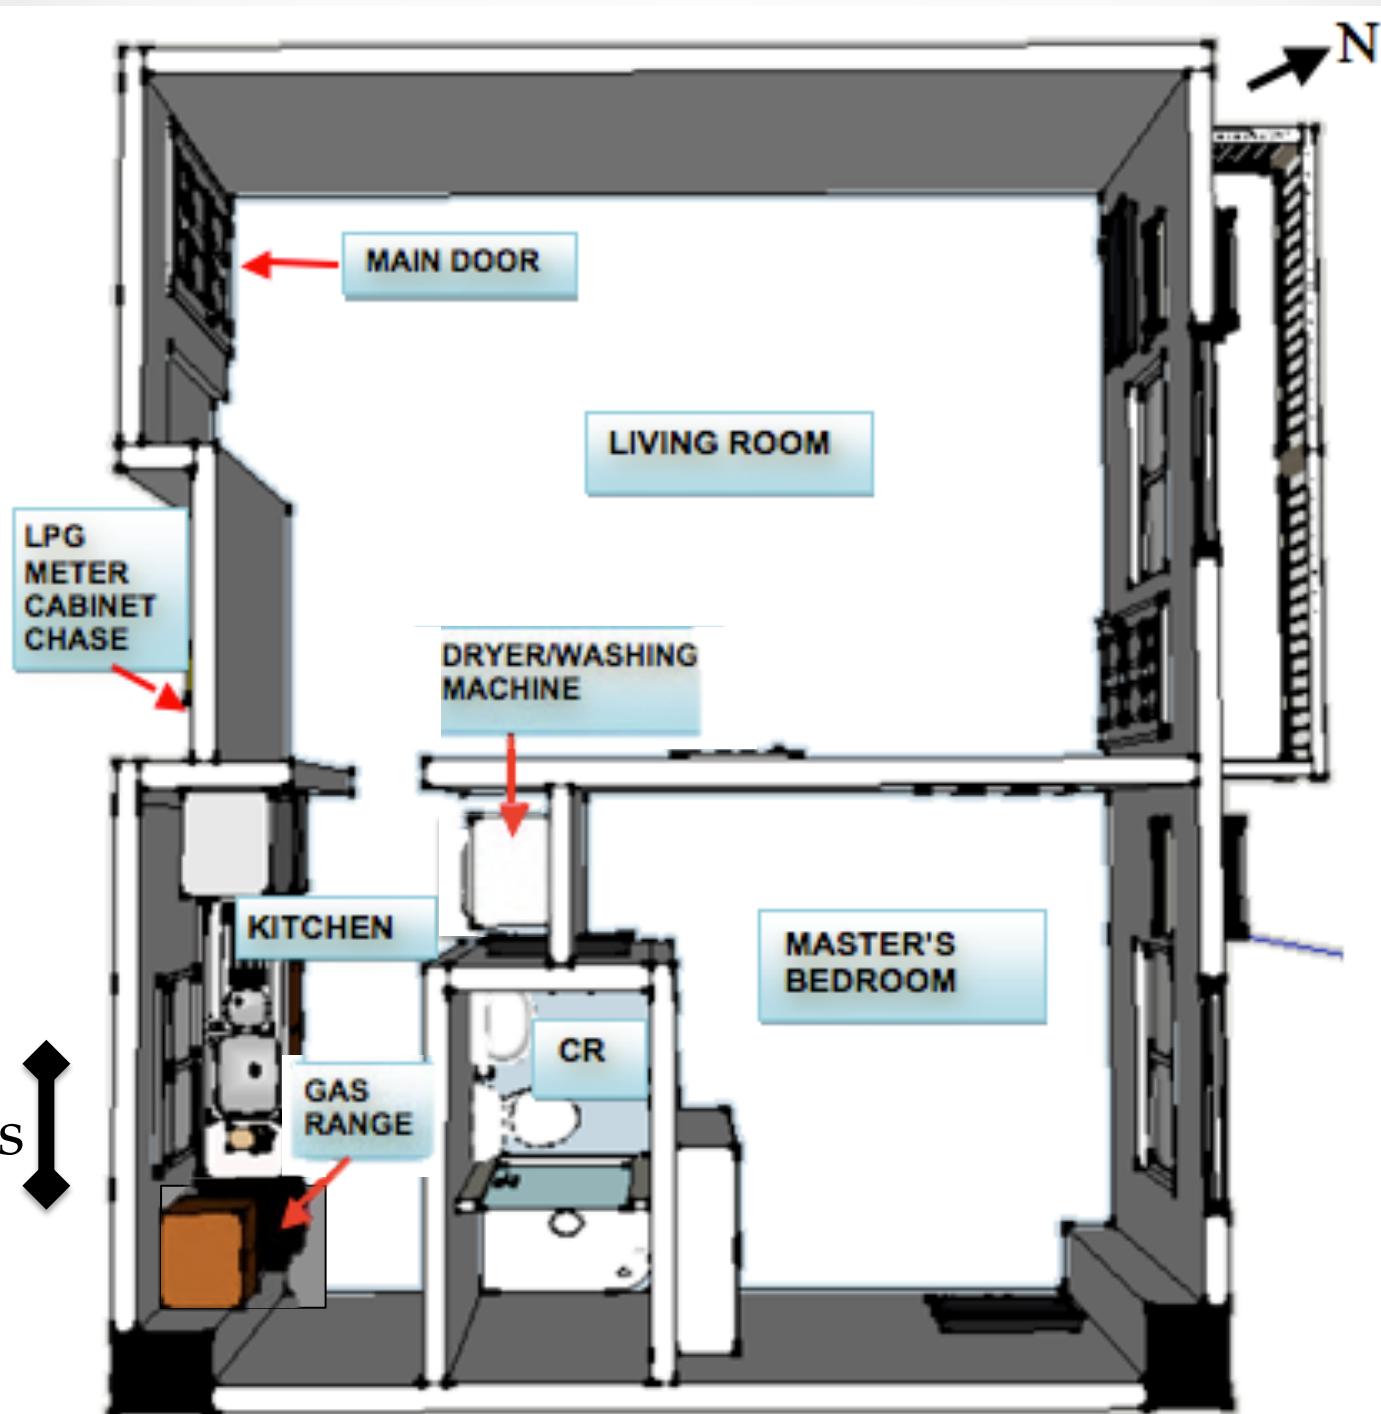
*not in scope of works approved
by Serendra

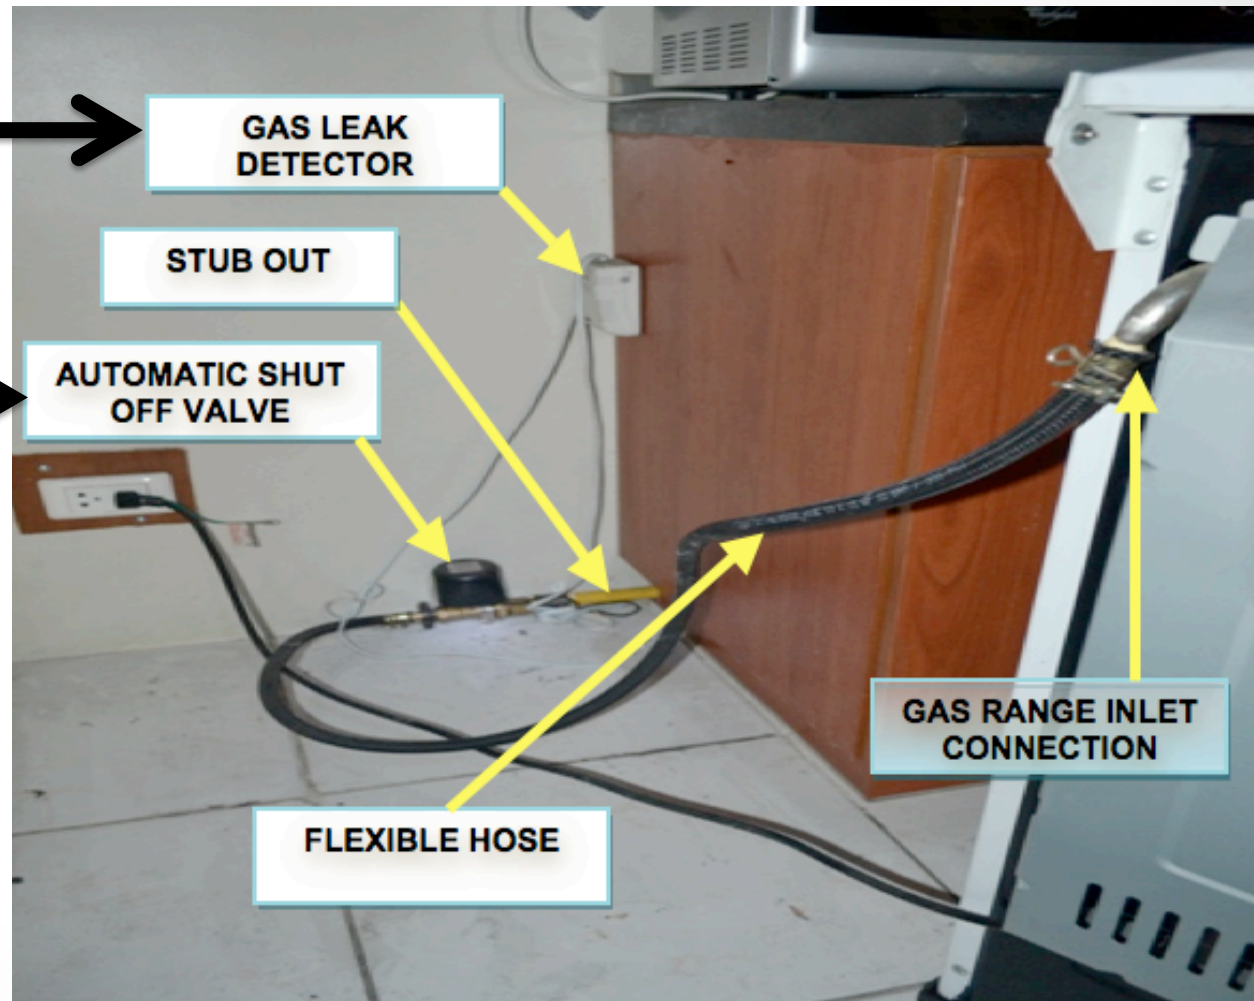
B1. Non-functional safety devices

Gas Leak Detector:

Unplugged OR the branch circuit for convenience outlets was turned off.

Automatic Shut-off Valve:

Electrically connected to the detector
A “normal-on” or “fail-open” design.

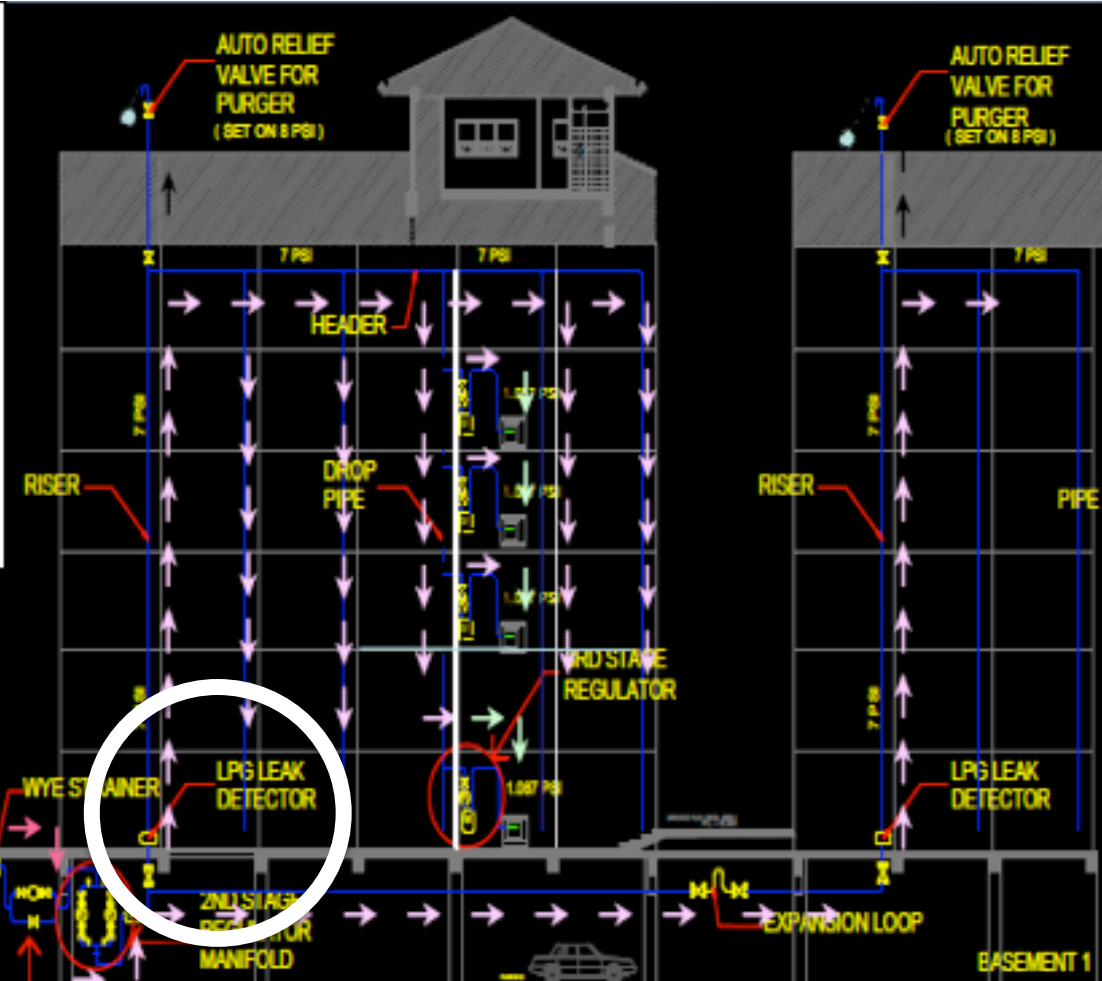
B2. Only one gas leak detector for the whole building. Lone building gas detector in Tower B did not activate.

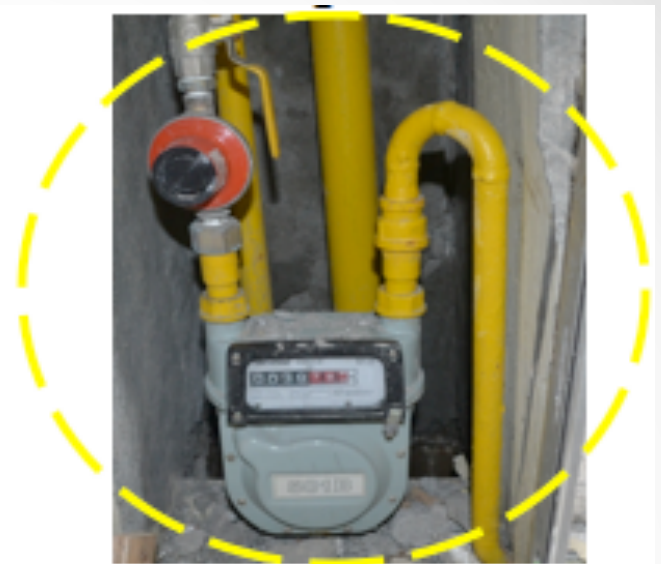
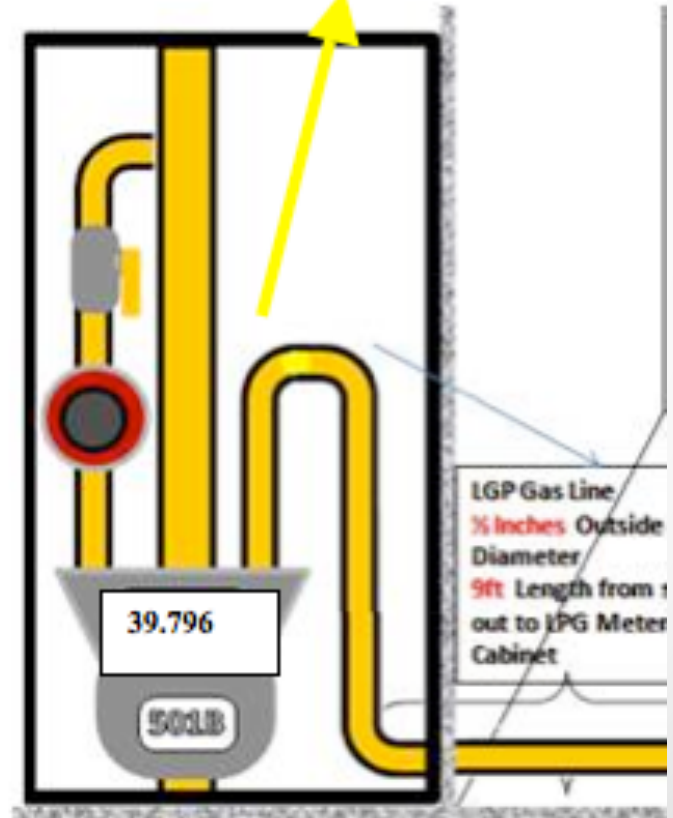
C. Unauthorized Access to Gas Valve

On May 31, at around 6:30 a.m., the gas valve was opened without the assistance of an authorized person.
